**Flood Control Project Maintenance
Levee Inspections**
LMA District Cover Sheet
Spring 2011 Levee Inspection Results

Reclamation District No. 1500 Sutter Basin

Waterway			Bank	Unit Miles
Unit No. 01 Sacramento River			Left	33.58

Levee Inspection Report By Mile - Spring 2011

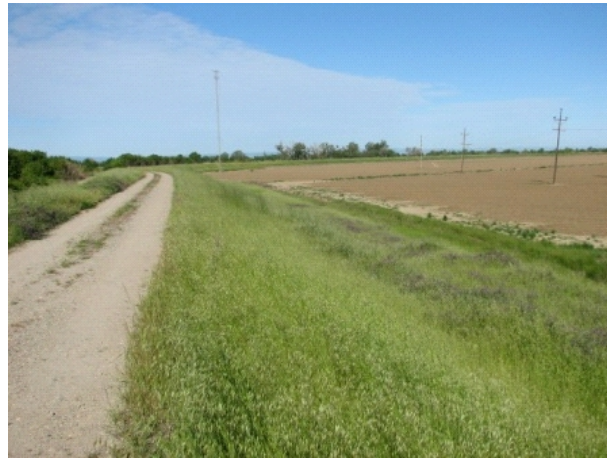
Levee Mile Report Line	1
Start Levee Mile	0.01
End Levee Mile	33.36
Location	Land Side
Category	Earthen Levee
Item	Vegetation

The photo is of the landside vegetation taller than 12".

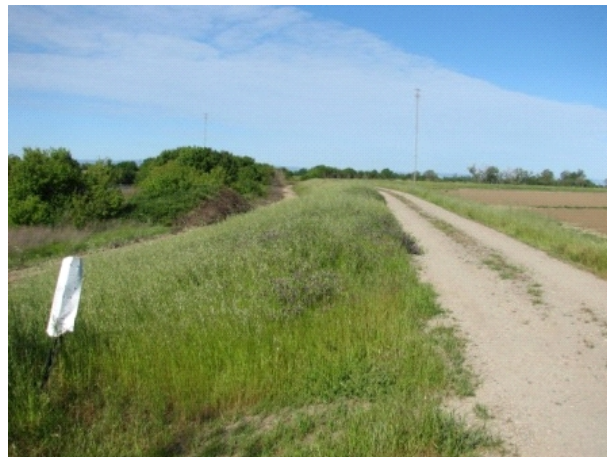
Levee Mile Report Line	2
Start Levee Mile	0.02
End Levee Mile	33.36
Location	Water Side
Category	Earthen Levee
Item	Vegetation

The vegetation on the waterside is taller than 12".

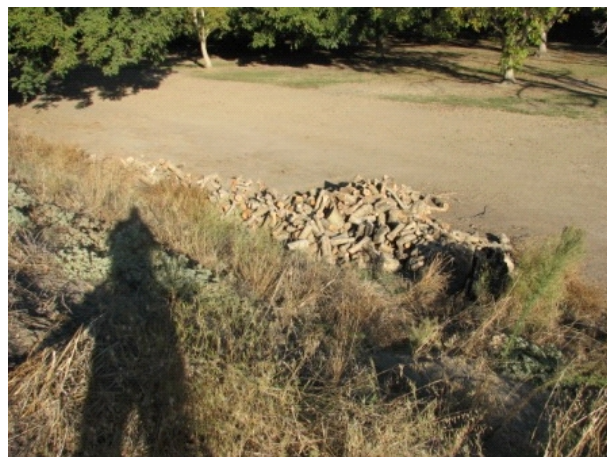
Levee Mile Report Line	4
Start Levee Mile	0.03
End Levee Mile	0.03
Location	Land Side
Category	Earthen Levee
Item	Encroachments

Fresh pile of firewood from this years prunings.

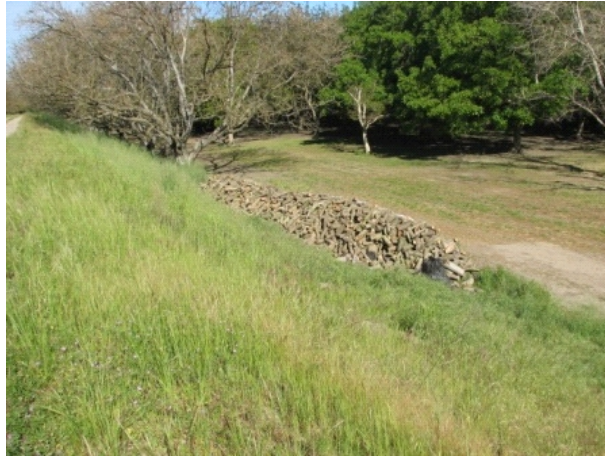
Levee Mile Report Line	4
Start Levee Mile	0.03
End Levee Mile	0.03
Location	Land Side
Category	Earthen Levee
Item	Encroachments
The firewood that was there last year has grown in size.	
Johngw_s_20110427_465.jpg

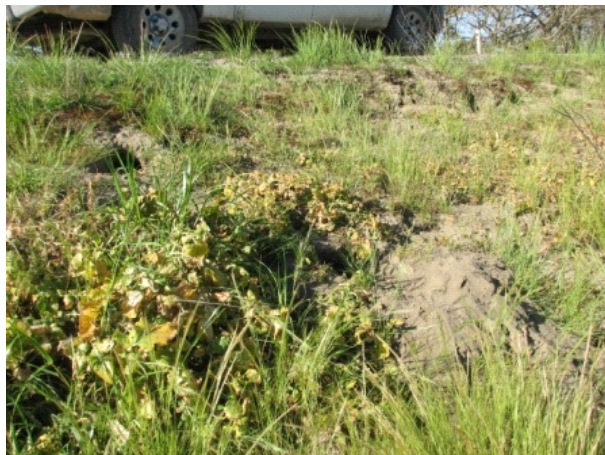
Levee Mile Report Line	5
Start Levee Mile	0.03
End Levee Mile	0.03
Location	Land Side
Category	Earthen Levee
Item	Animal Control
There are multiple rodents hole in the area.	
Johngw_s_20110427_466.jpg

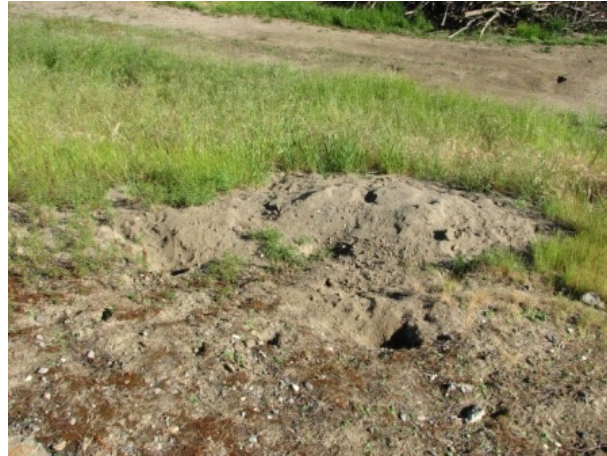
Levee Mile Report Line	5
Start Levee Mile	0.03
End Levee Mile	0.03
Location	Land Side
Category	Earthen Levee
Item	Animal Control

There are many rodent holes a short distance away from the last photo.

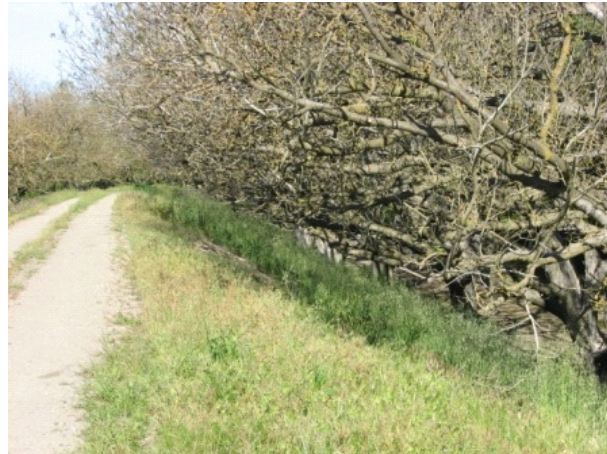
Levee Mile Report Line	6
Start Levee Mile	0.05
End Levee Mile	0.32
Location	Land Side
Category	Earthen Levee
Item	Trim / Thin Trees

The walnut trees need to be raised for visibility.

6	0.05	0.32	Earthen Levee	Trim / Thin Trees	LS	M	Trim trees to at least five feet above ground level. Inspector Comments: The walnut trees after harvest need to be trimmed up for the 5' clearness.	38.761060 ° -121.675505 °	38.763268 ° -121.679098 °	53 Y
7	0.07	0.07	Earthen Levee	Animal Control	LS	M	Exterminate rodents and backfill and compact or grout burrows.	38.761071 ° -121.675957 °	38.761071 ° -121.675957 °	5 Y
8	0.50	0.50	Earthen Levee	Encroachments	LS	M	Prunings	38.764474 ° -121.681819 °	38.764474 ° -121.681819 °	35 Y
9	0.51	0.51	Earthen Levee	Animal Control	LS	C	Exterminate rodents and backfill and compact or grout burrows.	38.764484 ° -121.681848 °	38.764484 ° -121.681848 °	960
10	1.30	1.30	Earthen Levee	Encroachments	WS	PO	Buildings Inspector Comments: pump house	38.769702 ° -121.691088 °	38.769702 ° -121.691088 °	3 Y
11	1.34	1.34	Earthen Levee	Encroachments	LS	CO	Landscaping Inspector Comments: retaining wall into levee	38.770003 ° -121.690607 °	38.770003 ° -121.690607 °	4 Y

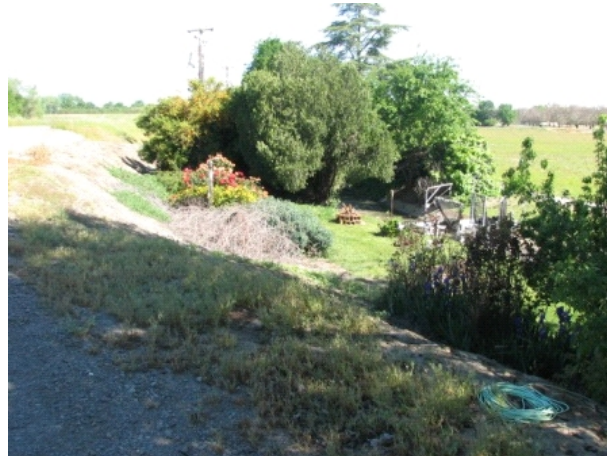
Levee Mile Report Line	15
Start Levee Mile	4.01
End Levee Mile	4.01
Location	Land Side
Category	Earthen Levee
Item	Encroachments
The landscape is planted into the encroachment zone within 15' of the toe.	
Johngw_s_20110427_476.jpg

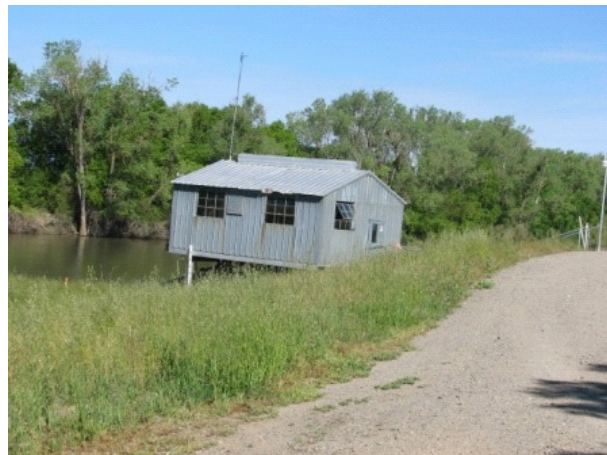
Levee Mile Report Line	16
Start Levee Mile	4.03
End Levee Mile	4.03
Location	Water Side
Category	Earthen Levee
Item	Encroachments
The building is the new pumping plant for Sutter Mutual Water. This replaces the abanded one.	
Johngw_s_20110427_477.jpg

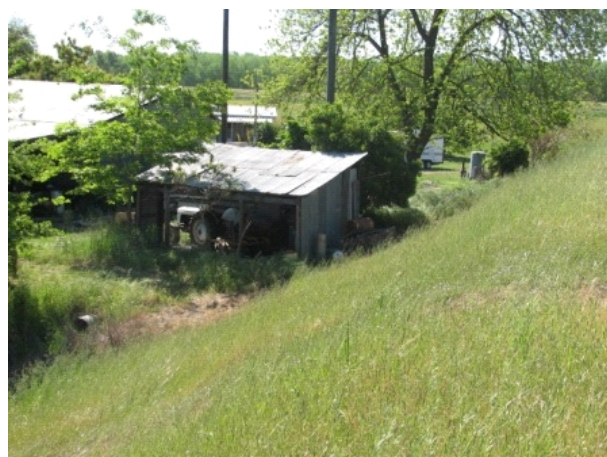
Levee Mile Report Line	18
Start Levee Mile	4.20
End Levee Mile	4.20
Location	Land Side
Category	Earthen Levee
Item	Encroachments
The equipment shed encroaches into the toe of the levee.	
Johngw_s_20110427_478.jpg

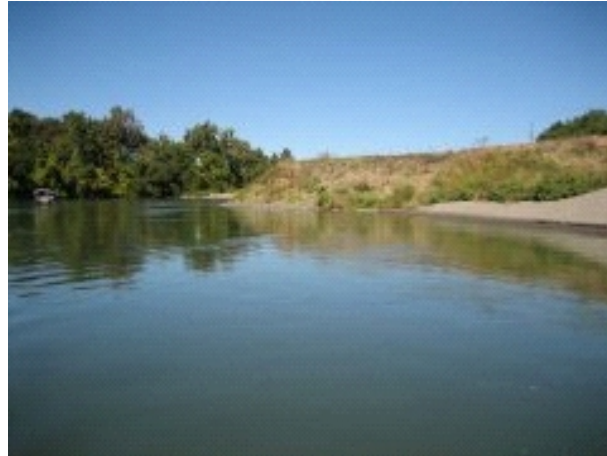
Levee Mile Report Line	26
Start Levee Mile	8.33
End Levee Mile	8.54
Location	Water Side
Category	Supplemental
Item	USACE Erosion Survey
2009: no berm, 2:1 slope, slumping, sands and silts, 3.32 ft/s [2009 SiteID:SAC_92-8_L]	
johngw_s_20110228_232.JPG

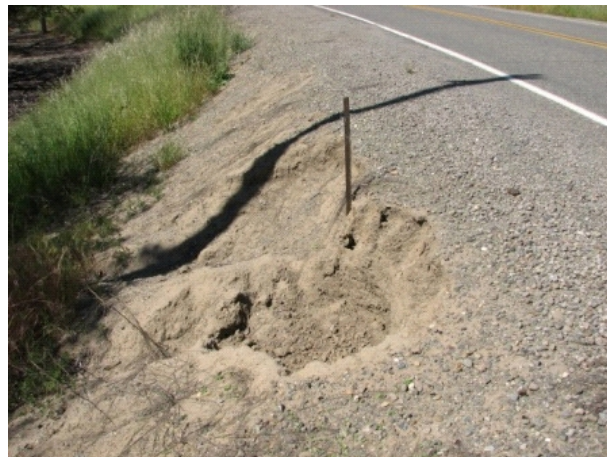
Levee Mile Report Line	27
Start Levee Mile	8.43
End Levee Mile	8.43
Location	Land Side
Category	Earthen Levee
Item	Erosion / Bank Caving
There has been some erosion along the roadside, need to repair the shoulder.	
Johngw_s_20110427_482.jpg

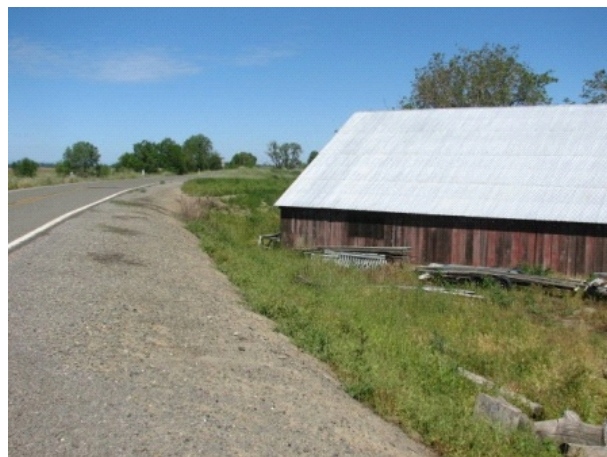
Levee Mile Report Line	28
Start Levee Mile	8.79
End Levee Mile	8.79
Location	Land Side
Category	Earthen Levee
Item	Encroachments
The corner of the building has encroached into the toe.	
Johngw_s_20110427_483.jpg

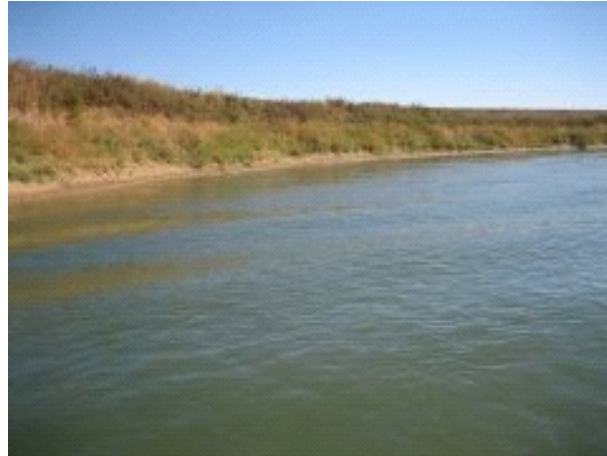
Levee Mile Report Line	29
Start Levee Mile	9.44
End Levee Mile	9.65
Location	Water Side
Category	Supplemental
Item	USACE Erosion Survey
2009: 15 ft berm, 1.5:1 slope, no stability issues, clays and silts, 3.37 ft/s [2009 SiteID:SAC_93-7_L]	
johngw_s_20110228_233.JPG

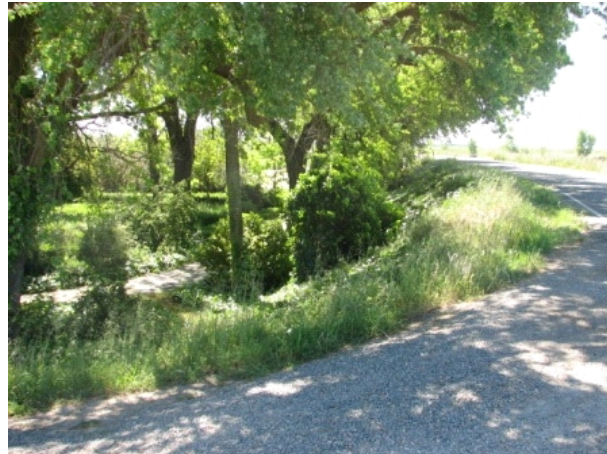
Levee Mile Report Line	30
Start Levee Mile	11.43
End Levee Mile	11.43
Location	Land Side
Category	Earthen Levee
Item	Encroachments
The homeowner has landscaped the levee slope.	
Johngw_s_20110427_484.jpg

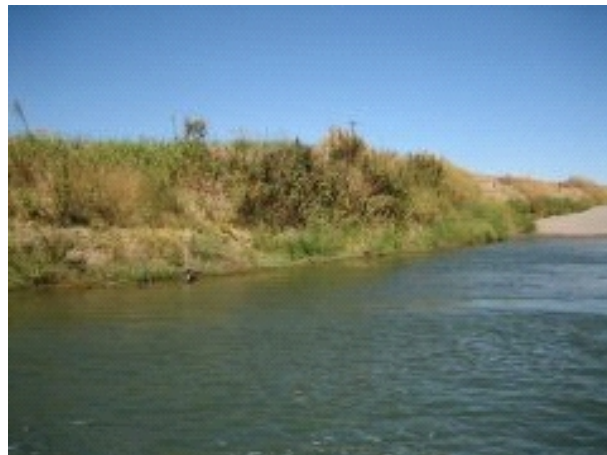
Levee Mile Report Line	32
Start Levee Mile	12.10
End Levee Mile	12.38
Location	Water Side
Category	Supplemental
Item	USACE Erosion Survey
2009: 15 ft berm, 1.5:1 slope, holes and slumping, clays and silts, 3.22 ft/s [2009 SiteID:SAC_96-2_L]	
johngw_s_20110228_235.JPG

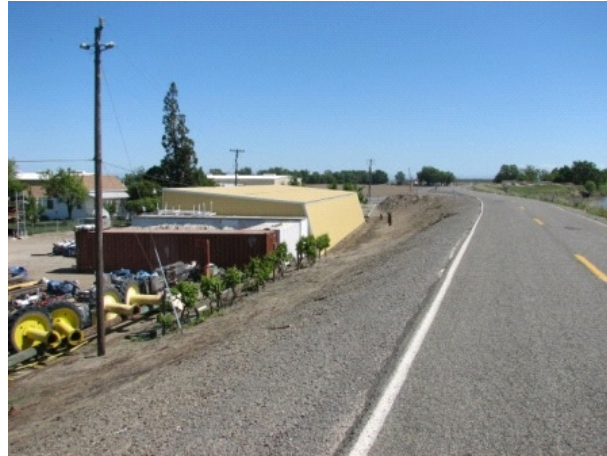
Levee Mile Report Line	37
Start Levee Mile	13.15
End Levee Mile	13.15
Location	Land Side
Category	Earthen Levee
Item	Encroachments
The buildings backside was built into the toe of the levee.	
Johngw_s_20110427_488.jpg

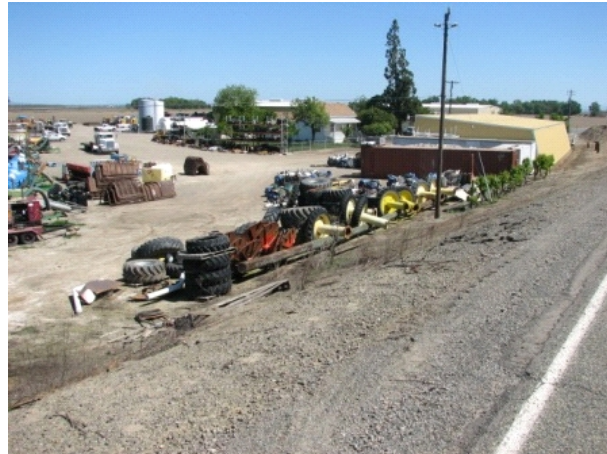
Levee Mile Report Line	38
Start Levee Mile	13.18
End Levee Mile	13.18
Location	Land Side
Category	Earthen Levee
Item	Encroachments
Next to the building there are tires and axles stored at the toe.	
Johngw_s_20110427_489.jpg

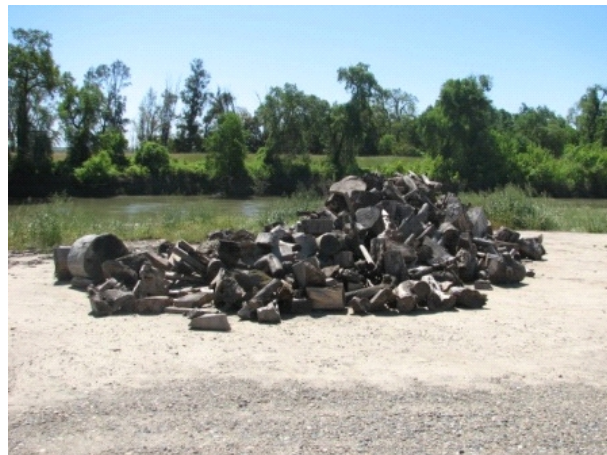
Levee Mile Report Line	39
Start Levee Mile	14.09
End Levee Mile	14.09
Location	Crown
Category	Earthen Levee
Item	Encroachments
Firewood has been stacked on top of the levee crown.	
Johngw_s_20110427_490.jpg

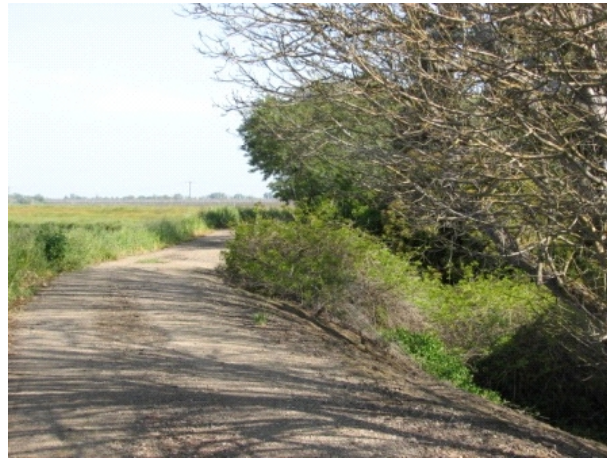
Levee Mile Report Line	43
Start Levee Mile	14.39
End Levee Mile	14.39
Location	Land Side
Category	Earthen Levee
Item	Encroachments
landscape shrubs on shoulder, Photo was taken in spring 2010.	
johnngw_s_20110228_229.jpg

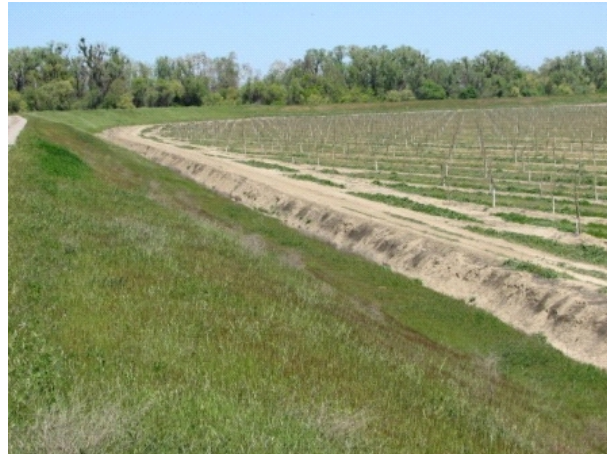
Levee Mile Report Line	44
Start Levee Mile	14.86
End Levee Mile	15.93
Location	Land Side
Category	Earthen Levee
Item	Encroachments
ag. ditch, Photo was taken in spring 2010.	
johnngw_s_20110228_242.jpg

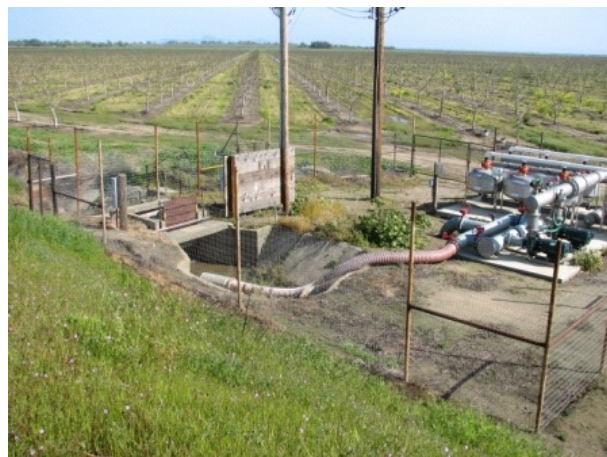
Levee Mile Report Line	45
Start Levee Mile	15.27
End Levee Mile	15.27
Location	Land Side
Category	Earthen Levee
Item	Encroachments
fence into levee toe, Photo was taken in spring 2010.	
johnngw_s_20110228_226.jpg

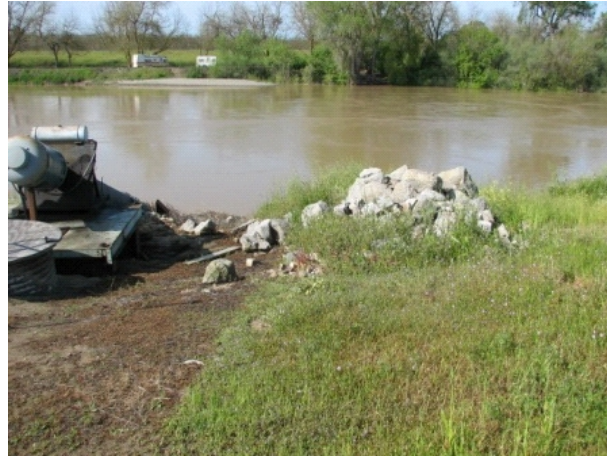
Levee Mile Report Line	46
Start Levee Mile	15.27
End Levee Mile	15.27
Location	Water Side
Category	Earthen Levee
Item	Encroachments
rip rap and concrete debris, Photo was taken in spring 2010.	
johnngw_s_20110228_225.jpg

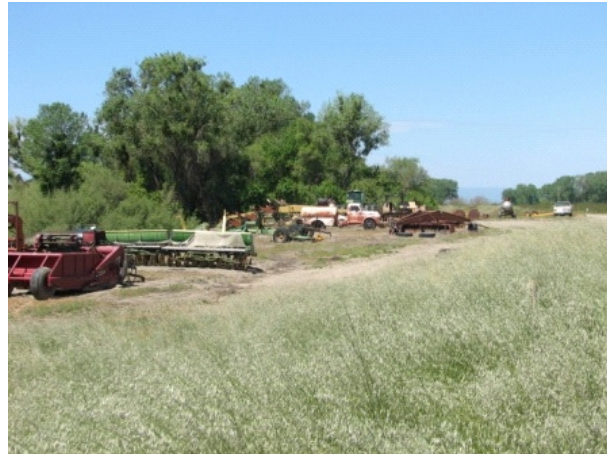
Levee Mile Report Line	47
Start Levee Mile	15.94
End Levee Mile	15.94
Location	Water Side
Category	Earthen Levee
Item	Encroachments
Farm equipment has been parked on the waterside berm.	
Johngw_s_20110427_491.jpg

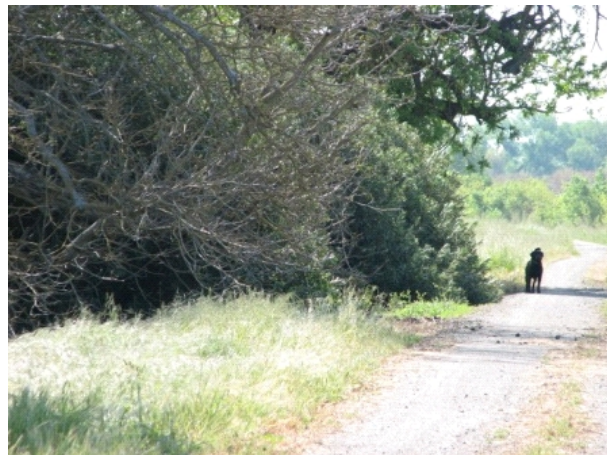
Levee Mile Report Line	48
Start Levee Mile	16.48
End Levee Mile	16.48
Location	Land Side
Category	Earthen Levee
Item	Encroachments
landscape shrubs, Photo was taken in spring 2010.	
johnngw_s_20110228_230.jpg

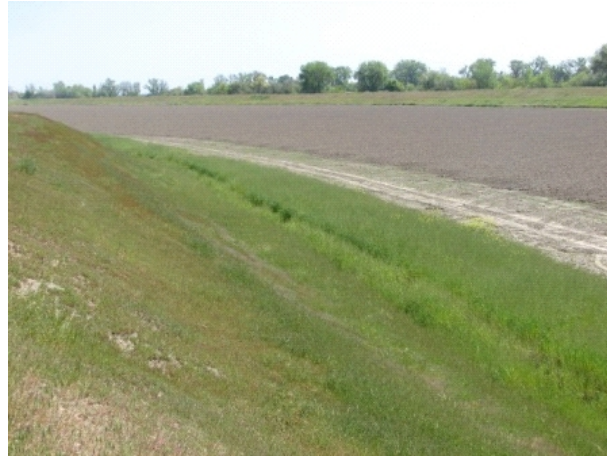
Levee Mile Report Line	49
Start Levee Mile	16.86
End Levee Mile	17.45
Location	Land Side
Category	Earthen Levee
Item	Encroachments
ag. ditch, Photo was taken in spring 2010.	
johngw_s_20110228_243.jpg

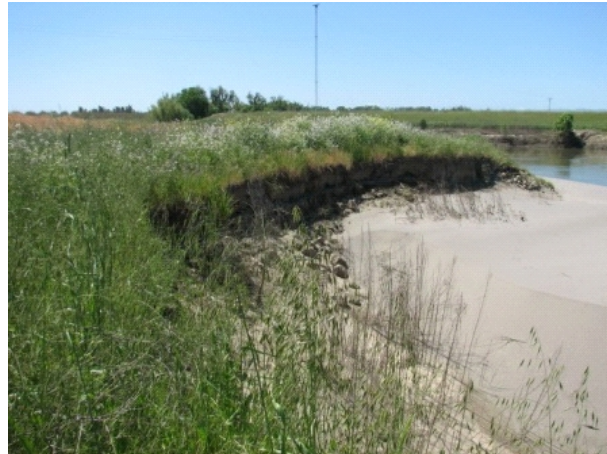
Levee Mile Report Line	50
Start Levee Mile	18.50
End Levee Mile	18.50
Location	Water Side
Category	Earthen Levee
Item	Erosion / Bank Caving
This is an inside curve in the river and erosion has occurred.	
Johngw_s_20110427_492.jpg

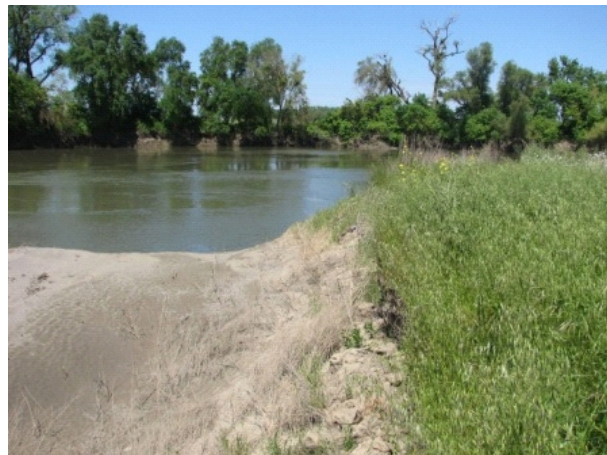
Levee Mile Report Line	50
Start Levee Mile	18.50
End Levee Mile	18.50
Location	Water Side
Category	Earthen Levee
Item	Erosion / Bank Caving
This is an upstream view of the same erosion.	
Johngw_s_20110427_493.jpg

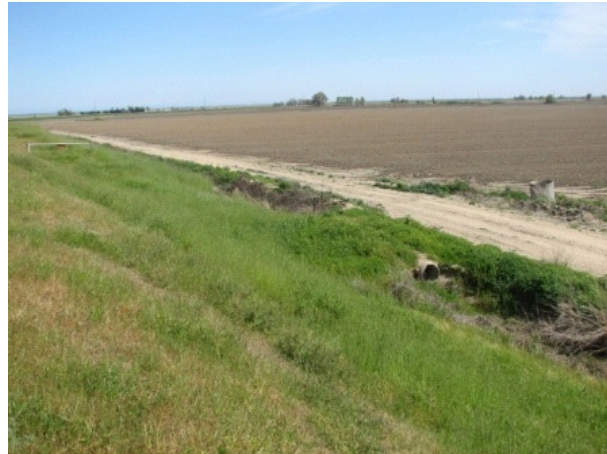
Levee Mile Report Line	64
Start Levee Mile	26.84
End Levee Mile	27.07
Location	Land Side
Category	Earthen Levee
Item	Encroachments
ag. ditch, Photo was taken in spring 2010.	
johnngw_s_20110228_247.jpg

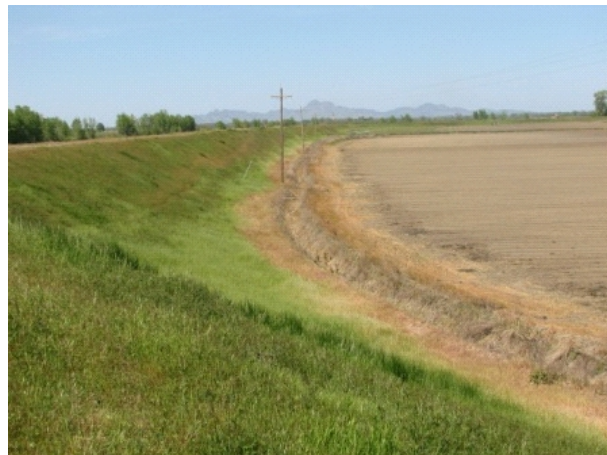
Levee Mile Report Line	65
Start Levee Mile	27.63
End Levee Mile	27.78
Location	Land Side
Category	Earthen Levee
Item	Encroachments
ag. ditch, Photo was taken in spring 2010.	
johnngw_s_20110228_248.jpg

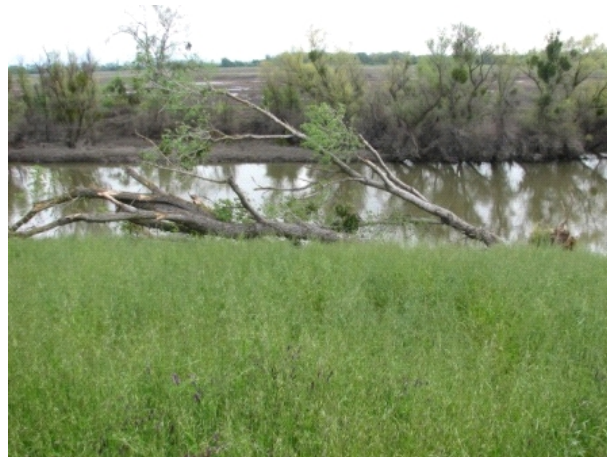
Levee Mile Report Line	7
Start Levee Mile	9.92
End Levee Mile	9.92
Location	Water Side
Category	Earthen Levee
Item	Trim / Thin Trees

A tree has been blown over and the roots have been up rooted. Need to repair the damage area.

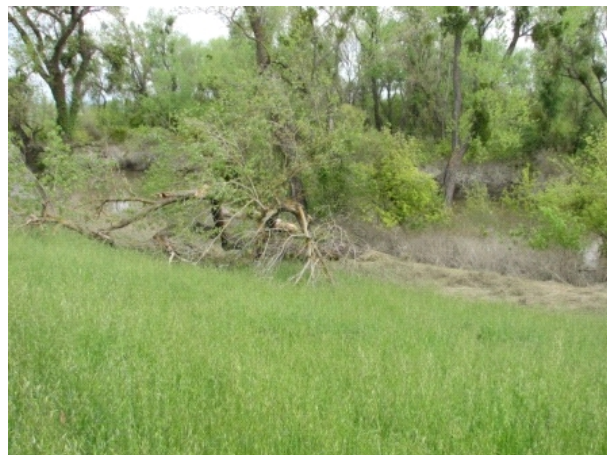
Levee Mile Report Line	9
Start Levee Mile	15.74
End Levee Mile	15.74
Location	Water Side
Category	Earthen Levee
Item	Trim / Thin Trees
The photo shows a fallen tree with root ball damage.	
johngw_s_20110425_460.jpg

9	15.74	15.74	Earthen Levee	Trim / Thin Trees	WS	W	Thin trees to allow visibility of the ground and room to flood fight. Inspector Comments: A cottonwod tree has fallen. Need to cut the tree up.Repair damage caused by the root ball at the toe.	38.963546 ° -121.689317 °	38.963546 ° -121.689317 °	9 Y
10	18.46	18.46	Earthen Levee	Trim / Thin Trees	WS	W	Thin trees to allow visibility of the ground and room to flood fight. Inspector Comments: A cottonwood tree has fallen. Need to cut the tree up. Repair the damage caused by the root ball.	38.989641 ° -121.727622 °	38.989641 ° -121.727622 °	10 Y
11	19.58	19.58	Earthen Levee	Animal Control	LS	C	Exterminate rodents and backfill and compact or grout burrows.	39.004558 ° -121.735557 °	39.004558 ° -121.735557 °	3
12	19.63	19.63	Earthen Levee	Trim / Thin Trees	WS	W	Thin trees to allow visibility of the ground and room to flood fight. Inspector Comments: A cottonwood tre has fallen. Need to cut up the tree. Repair the damage caused by the root ball.	39.005358 ° -121.735754 °	39.005358 ° -121.735754 °	11 Y

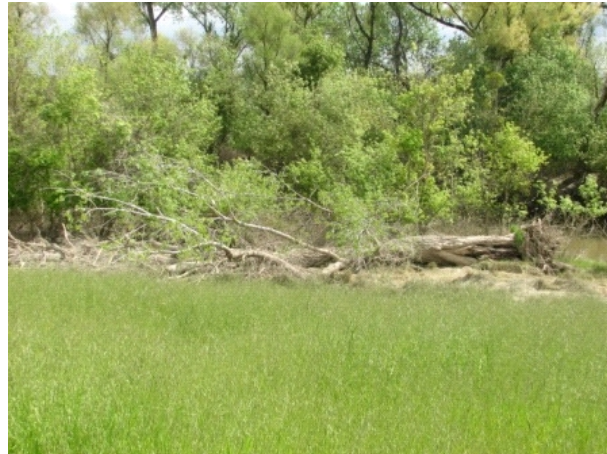
Levee Mile Report Line	12
Start Levee Mile	19.63
End Levee Mile	19.63
Location	Water Side
Category	Earthen Levee
Item	Trim / Thin Trees

On the waterside a tree has fallen and did some levee damage with the root ball.
